Contract #: 04-0120F4Cty: SF/ALA Rte: 80 PM: 13.2/13.9File #: 69.28**WELDING INSPECTION REPORT****Resident Engineer:**Pursell, Gary**Address:** 333 Burma Road**City:** Oakland, CA 94607**Report No:** WIR-016032**Date Inspected:** 03-Aug-2010**Project Name:** SAS Superstructure**OSM Arrival Time:** 700**Prime Contractor:** American Bridge/Fluor Enterprises, a JV**OSM Departure Time:** 1700**Contractor:** Zhenhua Port Machinery Company, Ltd (ZPMC), Changxing Island **Location:** Shanghai, China**CWI Name:** Mr. Huang min**CWI Present:** Yes No**Inspected CWI report:** Yes No N/A**Rod Oven in Use:** Yes No N/A**Electrode to specification:** Yes No N/A**Weld Procedures Followed:** Yes No N/A**Qualified Welders:** Yes No N/A**Verified Joint Fit-up:** Yes No N/A**Approved Drawings:** Yes No N/A**Approved WPS:** Yes No N/A**Delayed / Cancelled:** Yes No N/A**Bridge No:** 34-0006**Component:** Orthotropic Box Girder(OBG)**Summary of Items Observed:**

This CALTRANS OSM Quality Assurance Inspector (QA) Surendra Prabhu was present during the times noted above for observations relative to the fabrication of the Self Anchored Suspension (SAS) Superstructure being performed by Zhenhua Port Mach

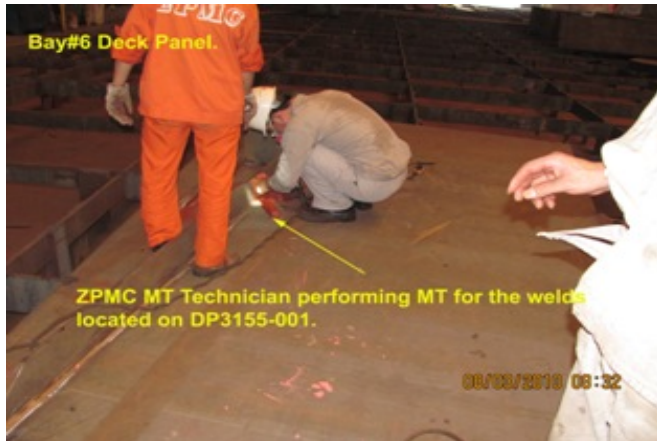
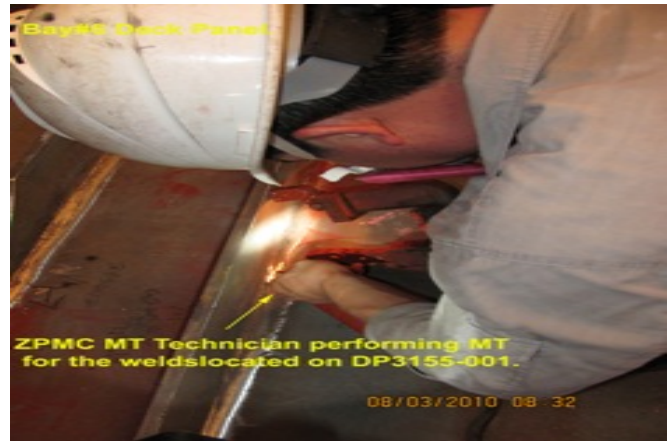
ZPMC personnel heat straightening OBG member identified as FB4103A. Distortion appeared to be caused by welding of the material. ZPMC Quality Control (QC) inspector identified as Mr. Xia Yong Zheng was present to monitor the heat straightening process. The heat straightening appeared to comply with Heat Straightening Report (HSR) HSR1 (B) 8926.

ZPMC MT Technician performing Magnetic Particle Testing on Deck panel welds located on DP3155-001. Refer the attached photos for reference.
